# MOISTURE CONTENT OF GLULAM TIMBERS

**in use in the  
pacific northwest**

PACIFIC NORTHWEST FOREST AND RANGE EXPERIMENT STATION  
U.S. DEPARTMENT OF AGRICULTURE FOREST SERVICE 1968

**Alfred E. Oviatt, Jr.**

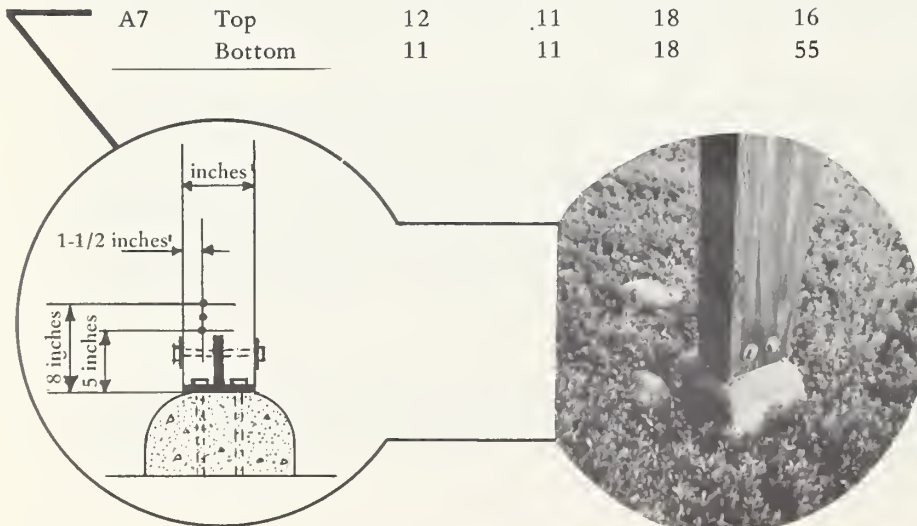
Figure 3.--Column base.  
(First National Bank,  
Seaside, Oregon.)

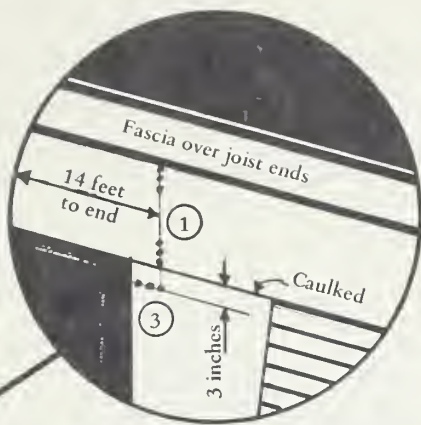
Figure 4.--Exposed beam-column joint facing ocean storms. (First National Bank, Seaside, Oregon.)

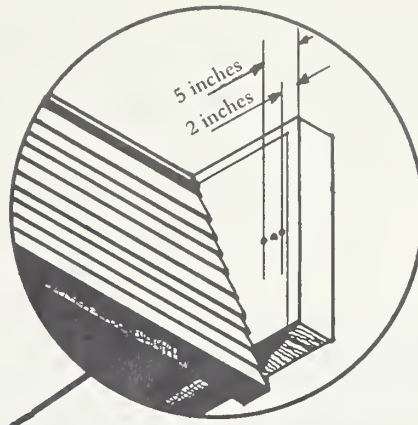
Figure 5.--Exposed beam end with copper cap. (First National Bank, Seaside, Oregon.)

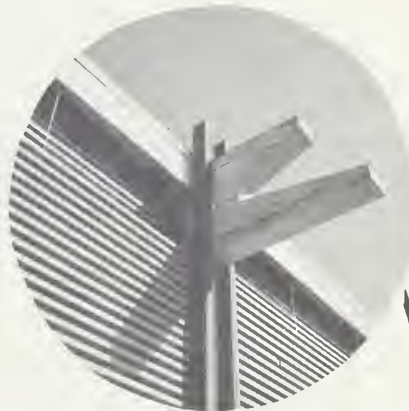
Figure 7.--Measurements just outside 2- by 4-inch louvre hanger. (Ice Pavilion, Bellevue, Washington.)

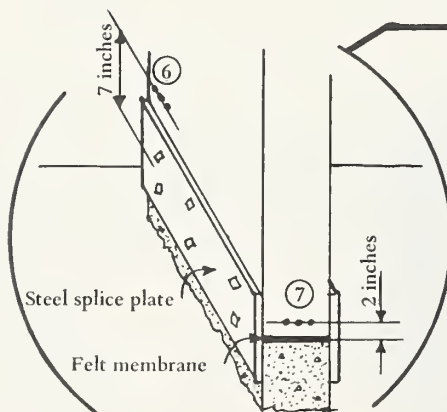
Figure 8.--SE column base.

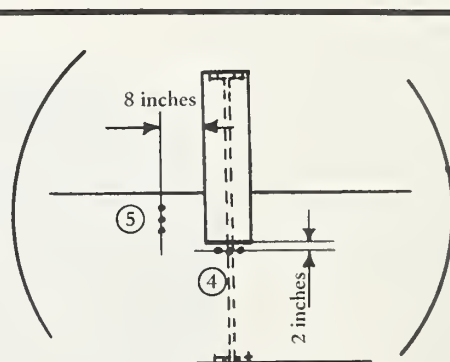
Figure 9.--Crossbeam notched for main beam.

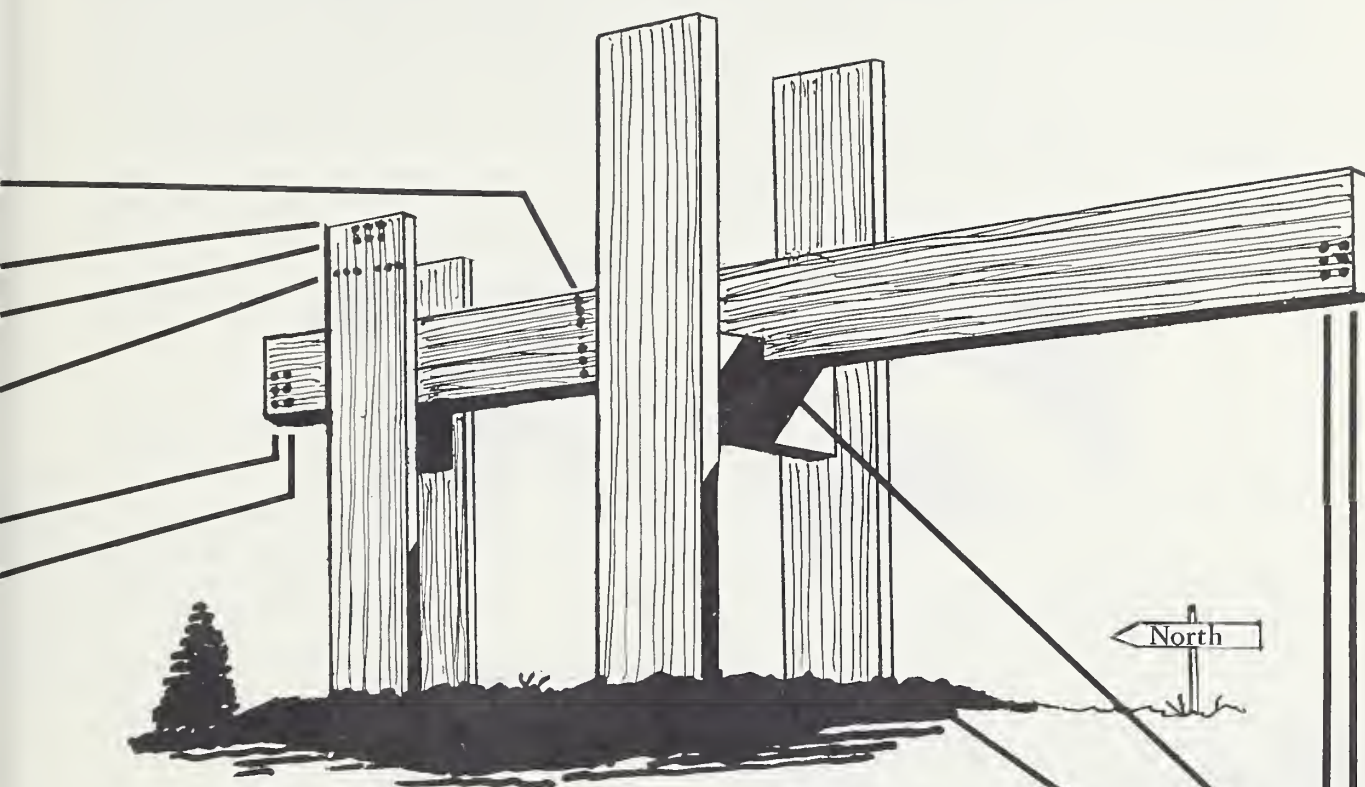
Figure 10.--Exposed sign structure of 14-1/2 by 53-1/2-inch unfinished western redcedar, near Portland, Oregon.

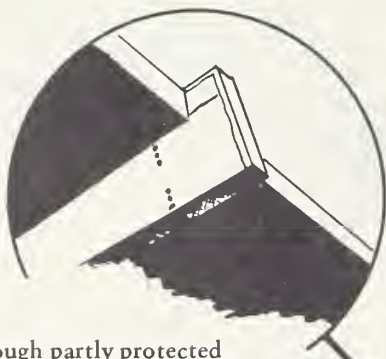
Figure 11.--Though partly protected by overhang, moisture feeds in from end-grain surface. (Public market at Seaside, Oregon.)

Location B3, shown in figure 11, appears reasonably sheltered, particularly in the top probe locations, and the projecting end of the beam is capped with copper. However, there is a filler block at the end of the beam to create an illusion of greater depth, and the joint shown probably admits water. Also, it should be noted that the copper cap extends just flush with the soffit of the beam and has no drip edge. It appears likely that water is absorbed at this edge by capillary action, and possibly along the sides of the cap.

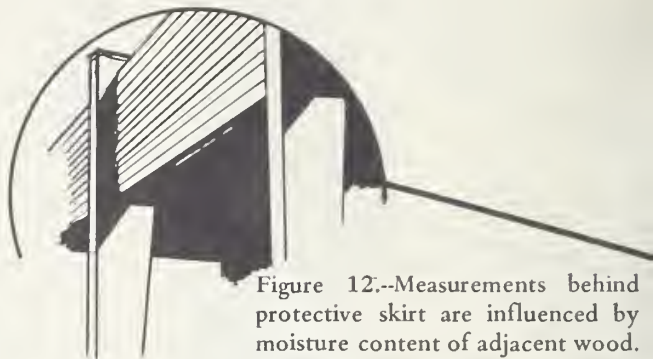
Figure 12.--Measurements behind protective skirt are influenced by moisture content of adjacent wood. (First National Bank, Seaside, Oregon.)

Member A6 is, in fact, largely exposed to the weather, but an opportunity occurred here to compare the moisture levels outside the protective skirt, as indicated for location A6S on page 00, with opposite location A6N inside the skirt and 8 inches above the lower protective edge. It appears here that the shelter furnished one portion of the member is largely bypassed by moisture movement through the wood for a distance of some 8 inches (fig. 12).

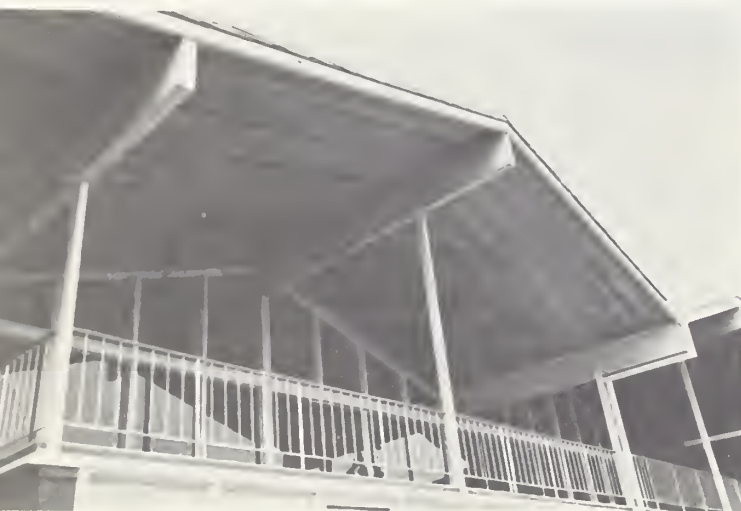
Figure 13.--Measurements at center of wide porch overhang indicate that this portion is well protected from sun and rain, even though unprotected ends absorb moisture. (George C. Marshall Community Center, Vancouver, Washington.)

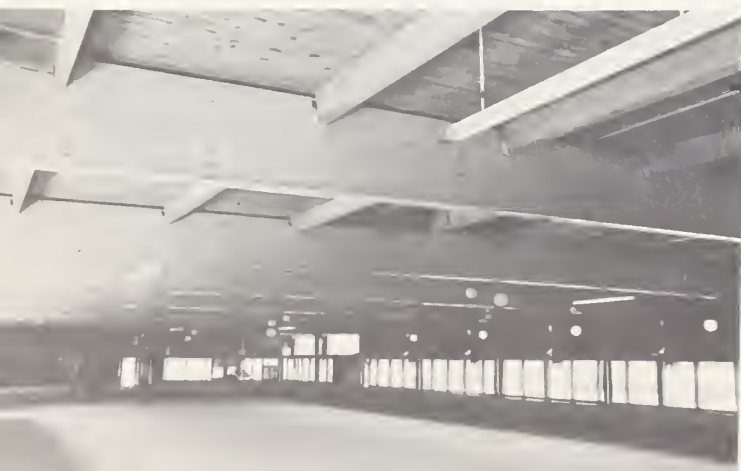
Figure 14.--Fully protected from sun and rain, these beams are subject to continuous circulation of exterior air through large roof ventilators and side louvers. Seasonal operation of ice rink from late September to early May probably materially increases severity of exposure. (Ice Pavilion, Bellevue, Washington.)

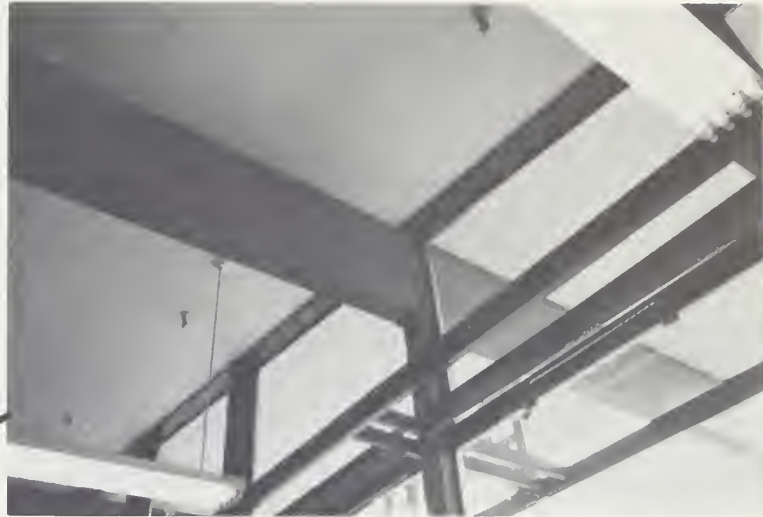
Figure 15.--Probes are located just inside shaded glass front of air-conditioned food market. (Public market, Seaside, Oregon.)

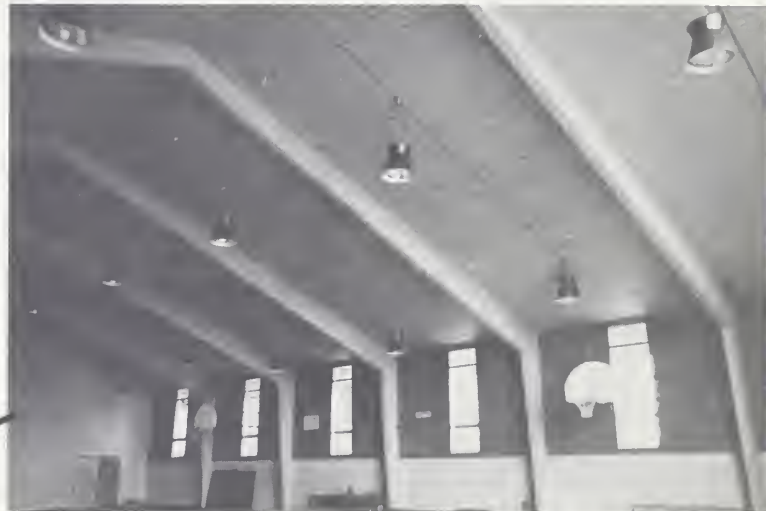
Figure 16.--About halfway up center roof leg of these rigid frames in a gymnasium, measurements do not indicate any significant moisture increase due to human activity and audience loads. (George C. Marshall Community Center, Vancouver, Washington.)

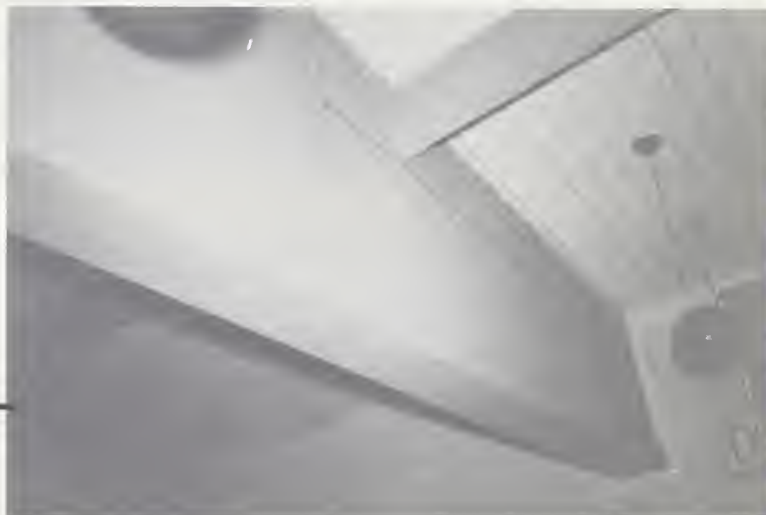
Figure 17.--Located at the top of a staircase and near a fan ventilator, this beam in a heated banquet area of the Silver Skate Ice Rink is very dry and noticeably surface checked. (Portland, Oregon.)

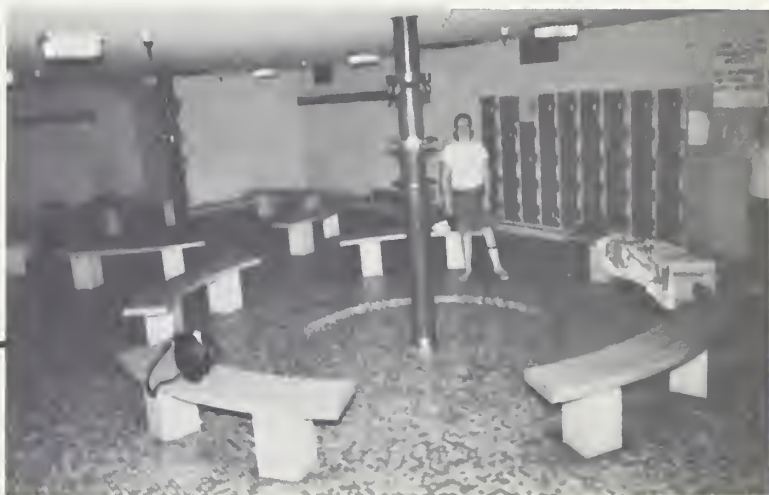
Figure 18.--Probes are located at middepth of 2-3/8 inches thick glulam seat board, placed 6 inches apart. Seats are exposed to intermittent spray from showers in center, but room is well ventilated. (George C. Marshall Community Center, Vancouver, Washington.)

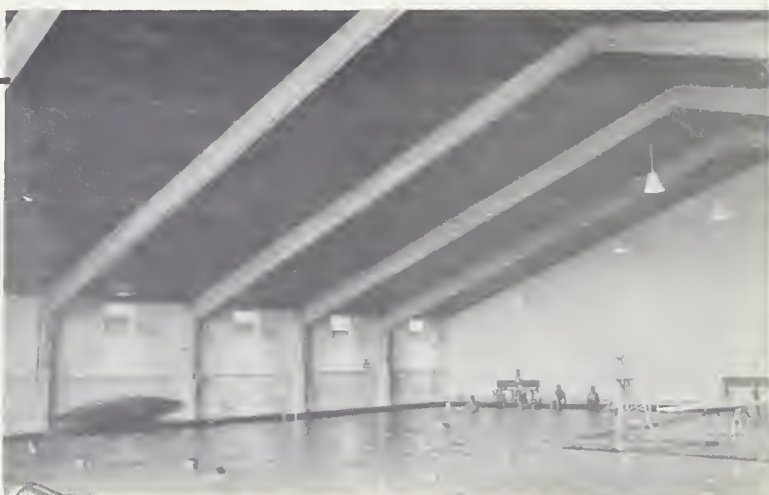
Figure 19.--Location 5 is at top and bottom of glulam roof leg of rigid frame over pool; locations 6 and 7 are in 4- by 6-inch western redcedar roof deck. Continuous condensation on large glass areas may help to keep vapor pressure and moisture content low. (George C. Marshall Community Center, Vancouver, Washington.)

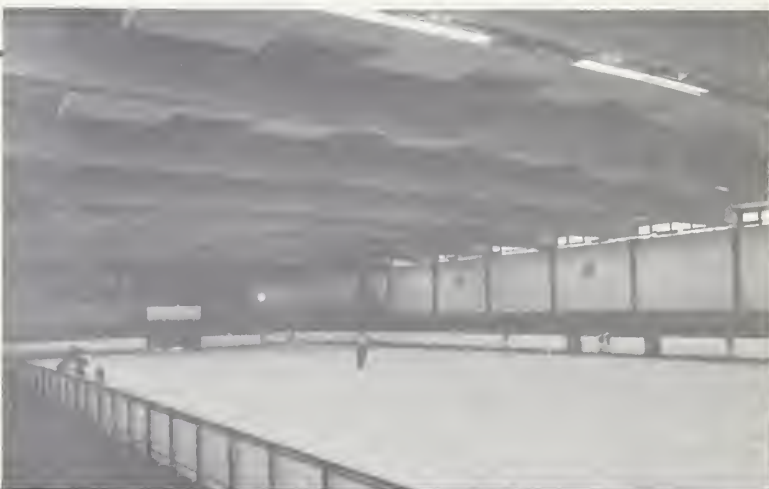
Figure 20.--Automatic dehumidifiers were installed in this rink to correct a prior condition of dripping from the beams onto the ice. No condensation is now seen on beams, and moisture content is held to a reasonable level. (Silver Skate Ice Rink, Portland, Oregon.)

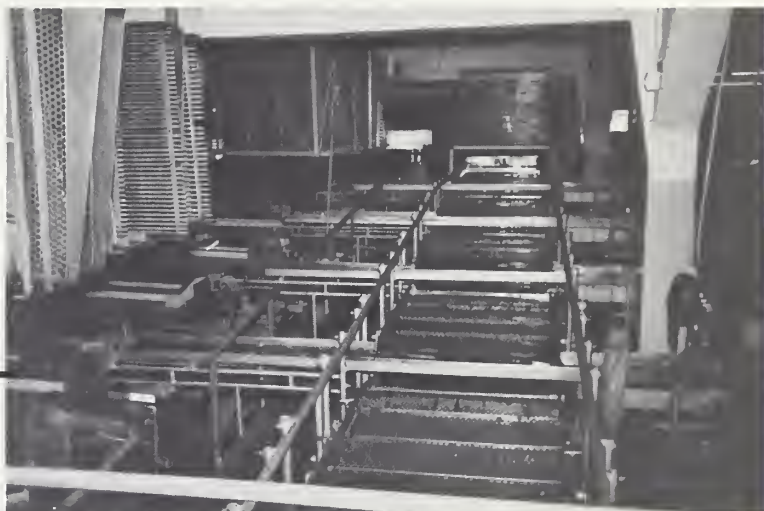
Figure 21.--Wet sorting conveyor is operated seasonally and entire area is hosed down after each shift. Sawn beam over this conveyor varies in moisture content with the pattern of operation. (Washington Cannery Coop., Vancouver, Washington.)

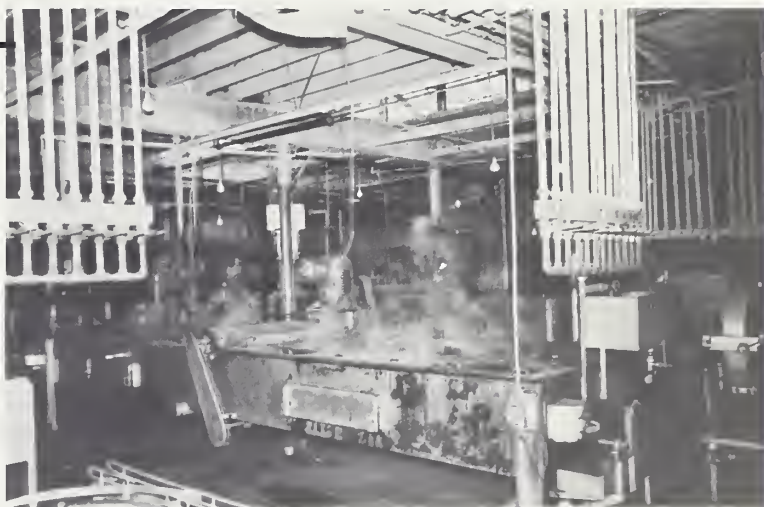
Figure 22.--Though not immediately above the cooker shown, this glulam beam is enveloped by steam from its operation and condensation forms in beads on its surfaces. Cookers are also operated seasonally with the sorting operation. (Washington Cannery Coop., Vancouver, Washington.)

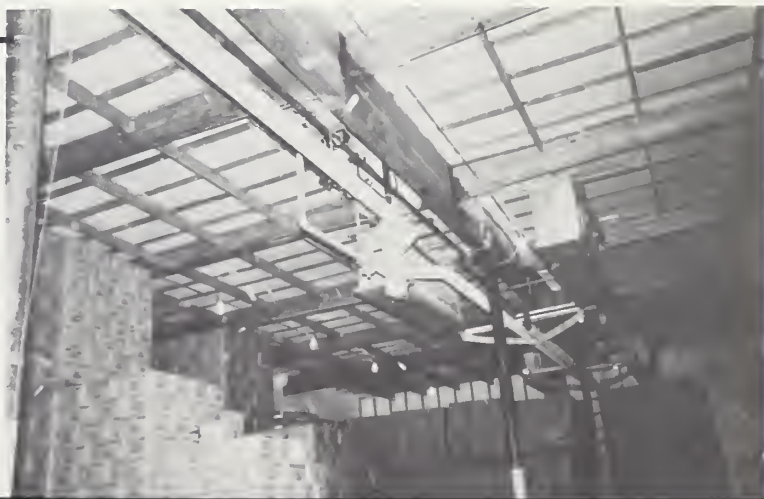
Figure 23.--Refrigerated storage space is operated from  $-10^{\circ}$  F. for frozen goods to  $35^{\circ}$  for temporary storage and is completely washed down and fumigated between loads. The moisture load of the stored vegetables is variable in this example. (Washington Cannery Coop., Vancouver, Washington.)
